NSWC TR 81-327

SAFETY EVALUATION OF "PHOTO FINISH"

RESEARCH AND TECHNOLOGY DEPARTMENT

20. ABSTRACT (Continue on reverse side if necessary and identify by block number) Li/So ₂ batteries are used to provide power for an air deployable expendable store "Photo Finish". This report presents results of a test program to determine if the system is safe for fleet use.

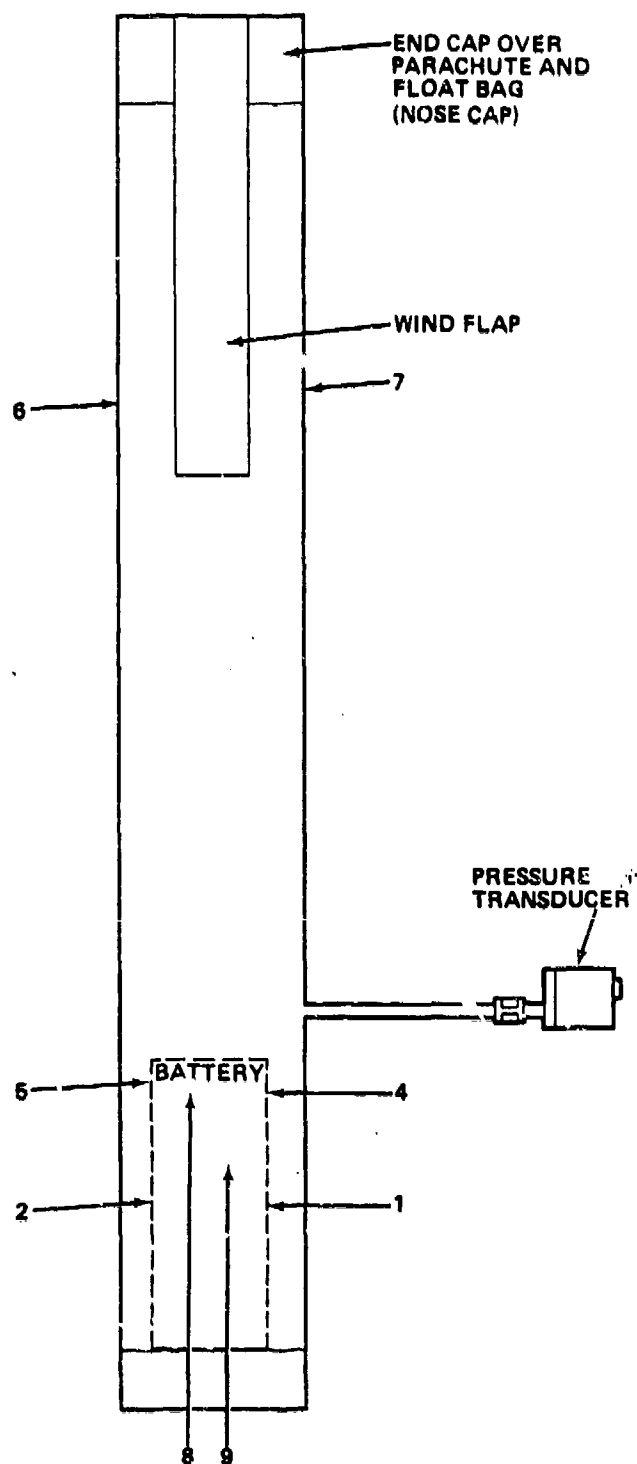
FIGURE 1 SCHEMATIC OF "PHOTO FINISH" SHOWING LOCATION OF THERMOCOUPLES AND PRESSURE TRANSDUCER AS POSITIONED FOR TEST.

Pressures were measured using a Standard Controls Model Number 1200-41-1 pressure transducer. Type K thermocouples were used to measure the temperatures at several points on the package containing the four batteries. Thermocouple location on the complete battery package and "PHOTO FINISH" housing is indicated in Figure 1. A photograph of the battery package is shown in Figure 2.

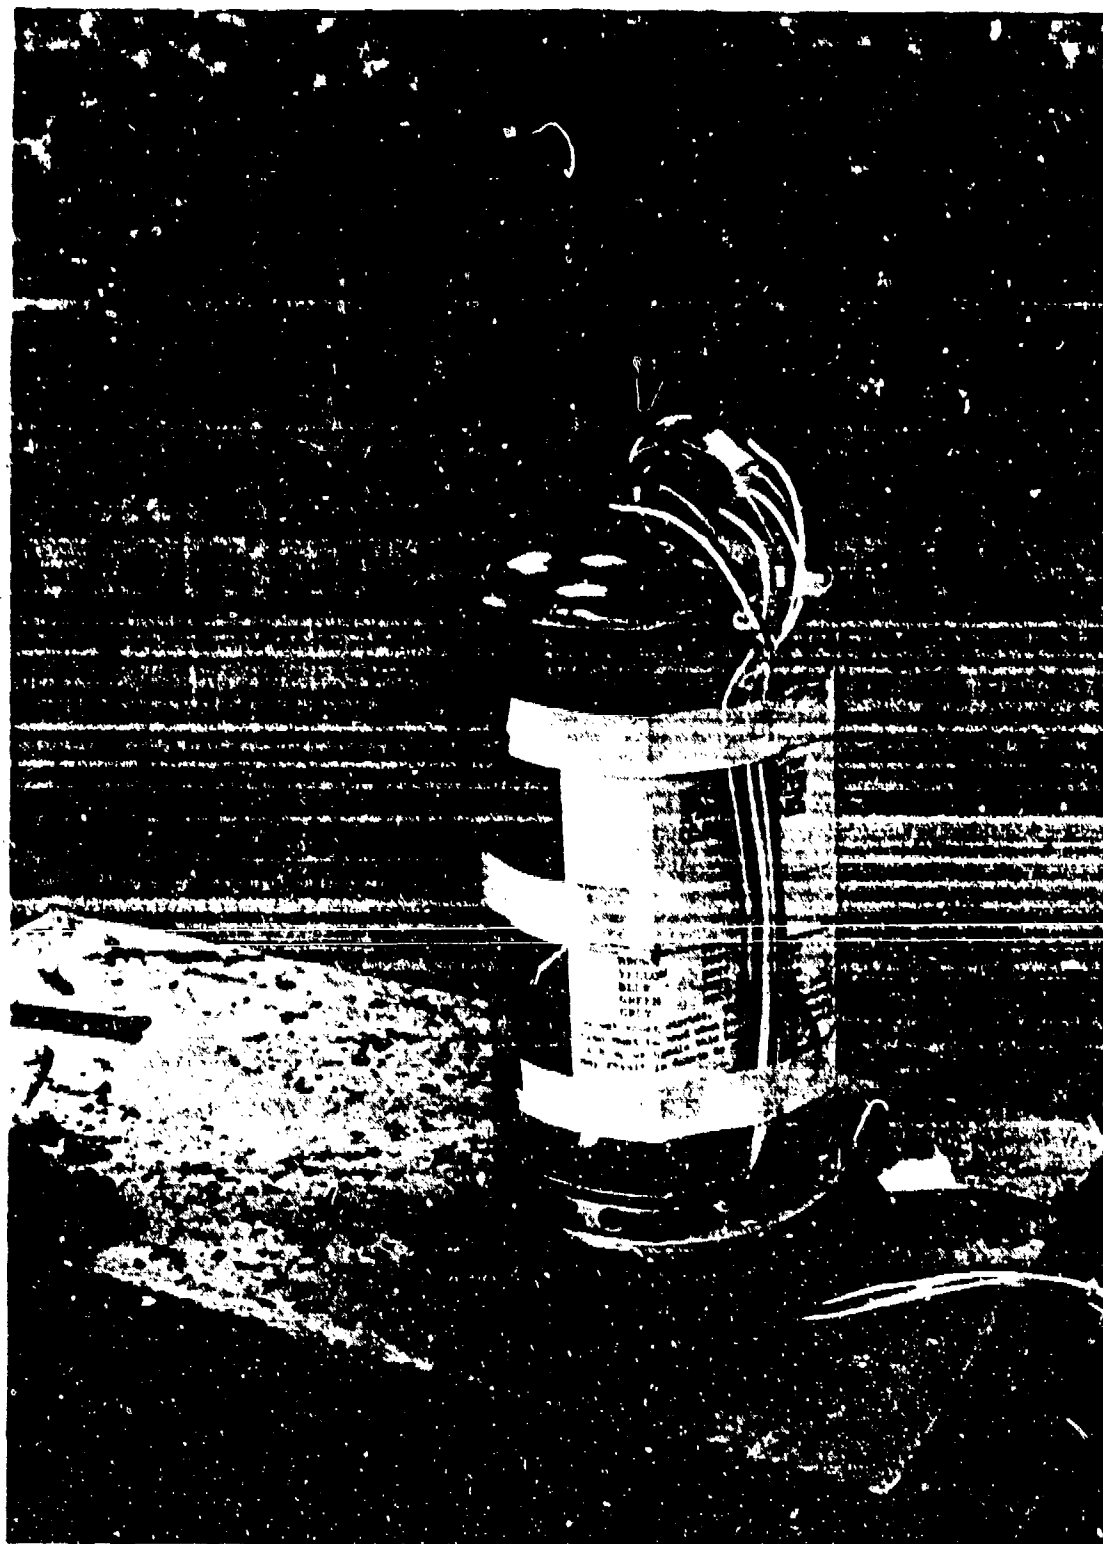
FIGURE 2 PHOTOGRAPH OF BATTERY PACKAGE. THE POWER SUPPLIES USED TO POWER "PHOTO FINISH" ARE CONTAINED INSIDE THIS PACKAGE.

1. Battery number one has thirteen L026SH lithium sulfur dioxide cells wired in series.
2. Battery number two has four L026SH lithium sulfur dioxide cells wired in series.
3. Batteries three and four each have two L032S lithium sulfur dioxide cells wired in series.

Batteries one and two each have a thermal fuse (80-90°C) and a four ampere fuse in the ground leg. Batteries three and four each have a three ampere fuse in the ground leg. This combination of fuses protects against short circuit and excessive discharge rates.

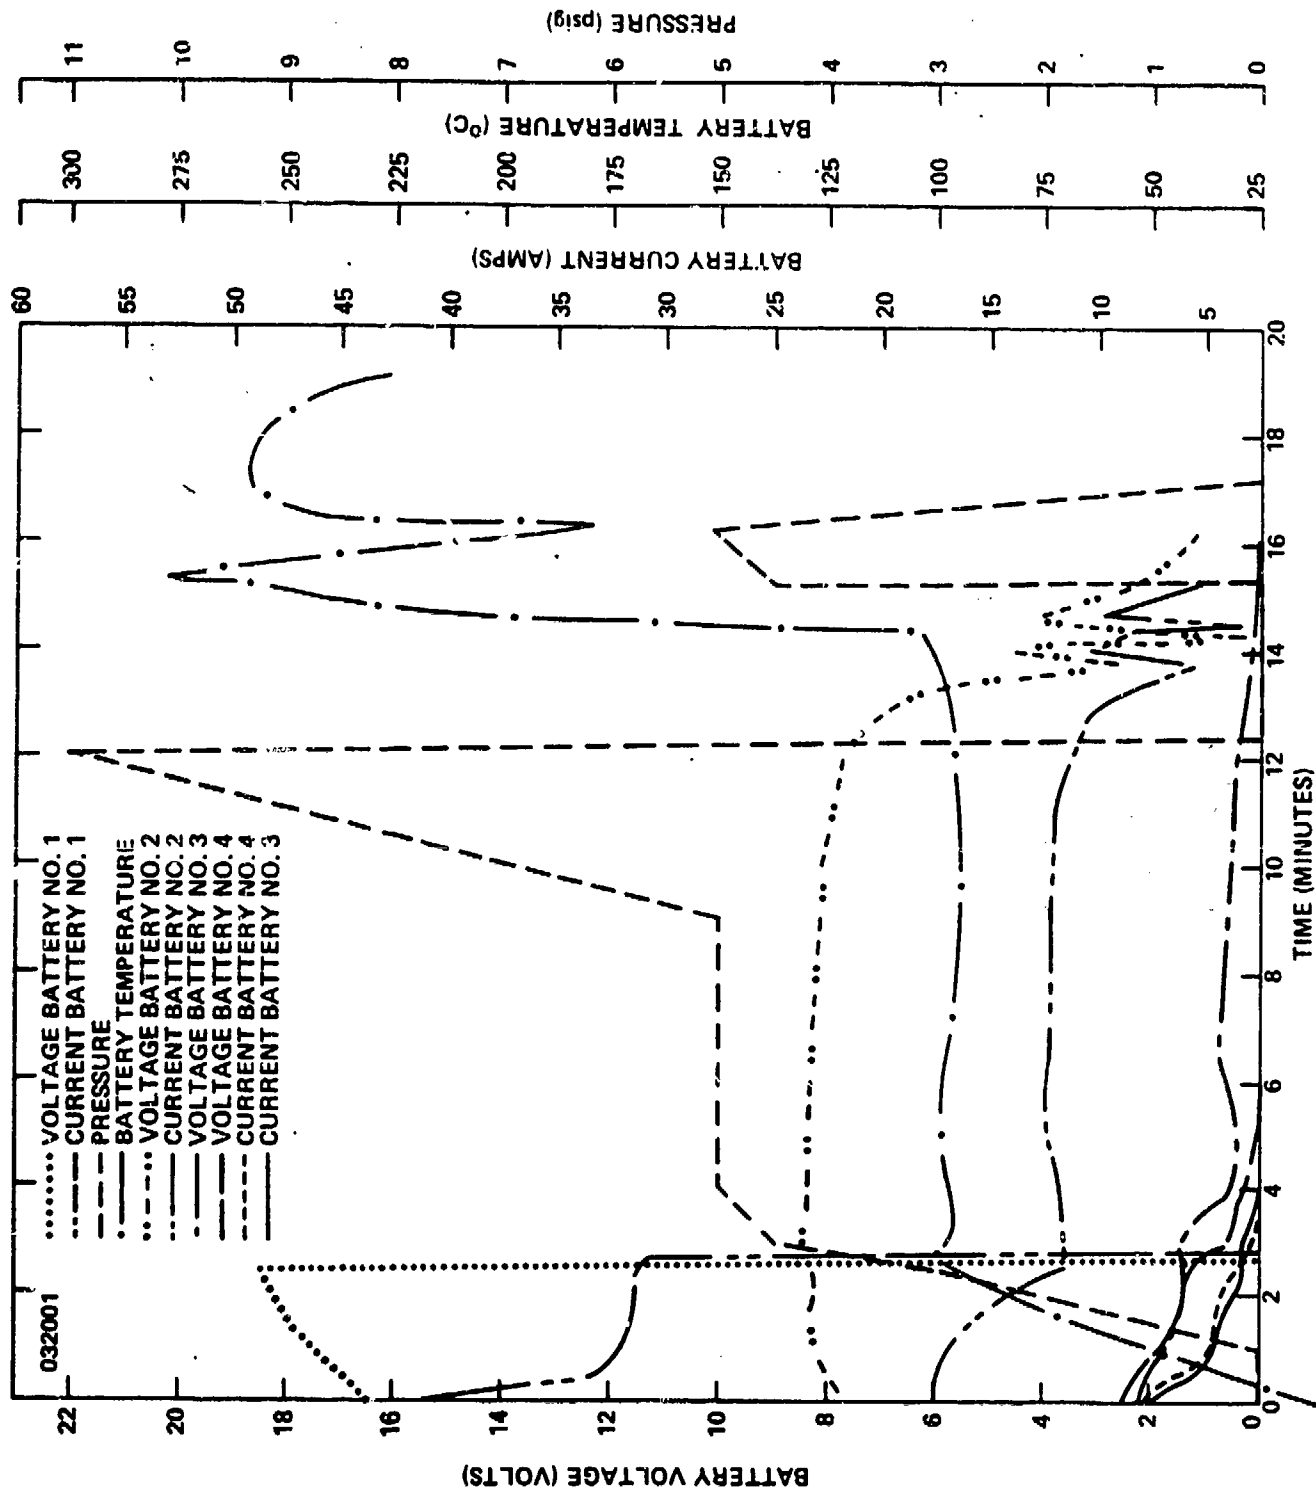
FIGURE 3 SHORT CIRCUIT OF ALL FOUR "PHOTO FINISH" BATTERY SUPPLIES. SHORT CIRCUIT CURRENT AND BATTERY VOLTAGES ARE INDICATED FOR EACH BATTERY. HOUSING PRESSURE AND BATTERY PACK TEMPERATURE ARE ALSO SHOWN.

The first series of tests was simultaneous short-circuiting of all four batteries within the pack (all fuses bypassed) through 0.4 ohm loads. The above test was repeated three times. All three tests resulted in venting of the batteries. However, the first two tests resulted in low housing pressure upon venting. A post mortem of these units indicated that the housing leaked where the thermocouples and voltage leads exited the unit. The problem was corrected and a third short circuit test was run. The results of the third run are presented in Figure 3. Maximum pressure observed is 11 psig. The ventings caused the nose cap to be ejected at approximately 10 ft/sec. This velocity was measured using high speed photography and video techniques. After nose cap ejection the float bag inflated and subsequently burst. A summary of the short circuit data is presented in Table 1.

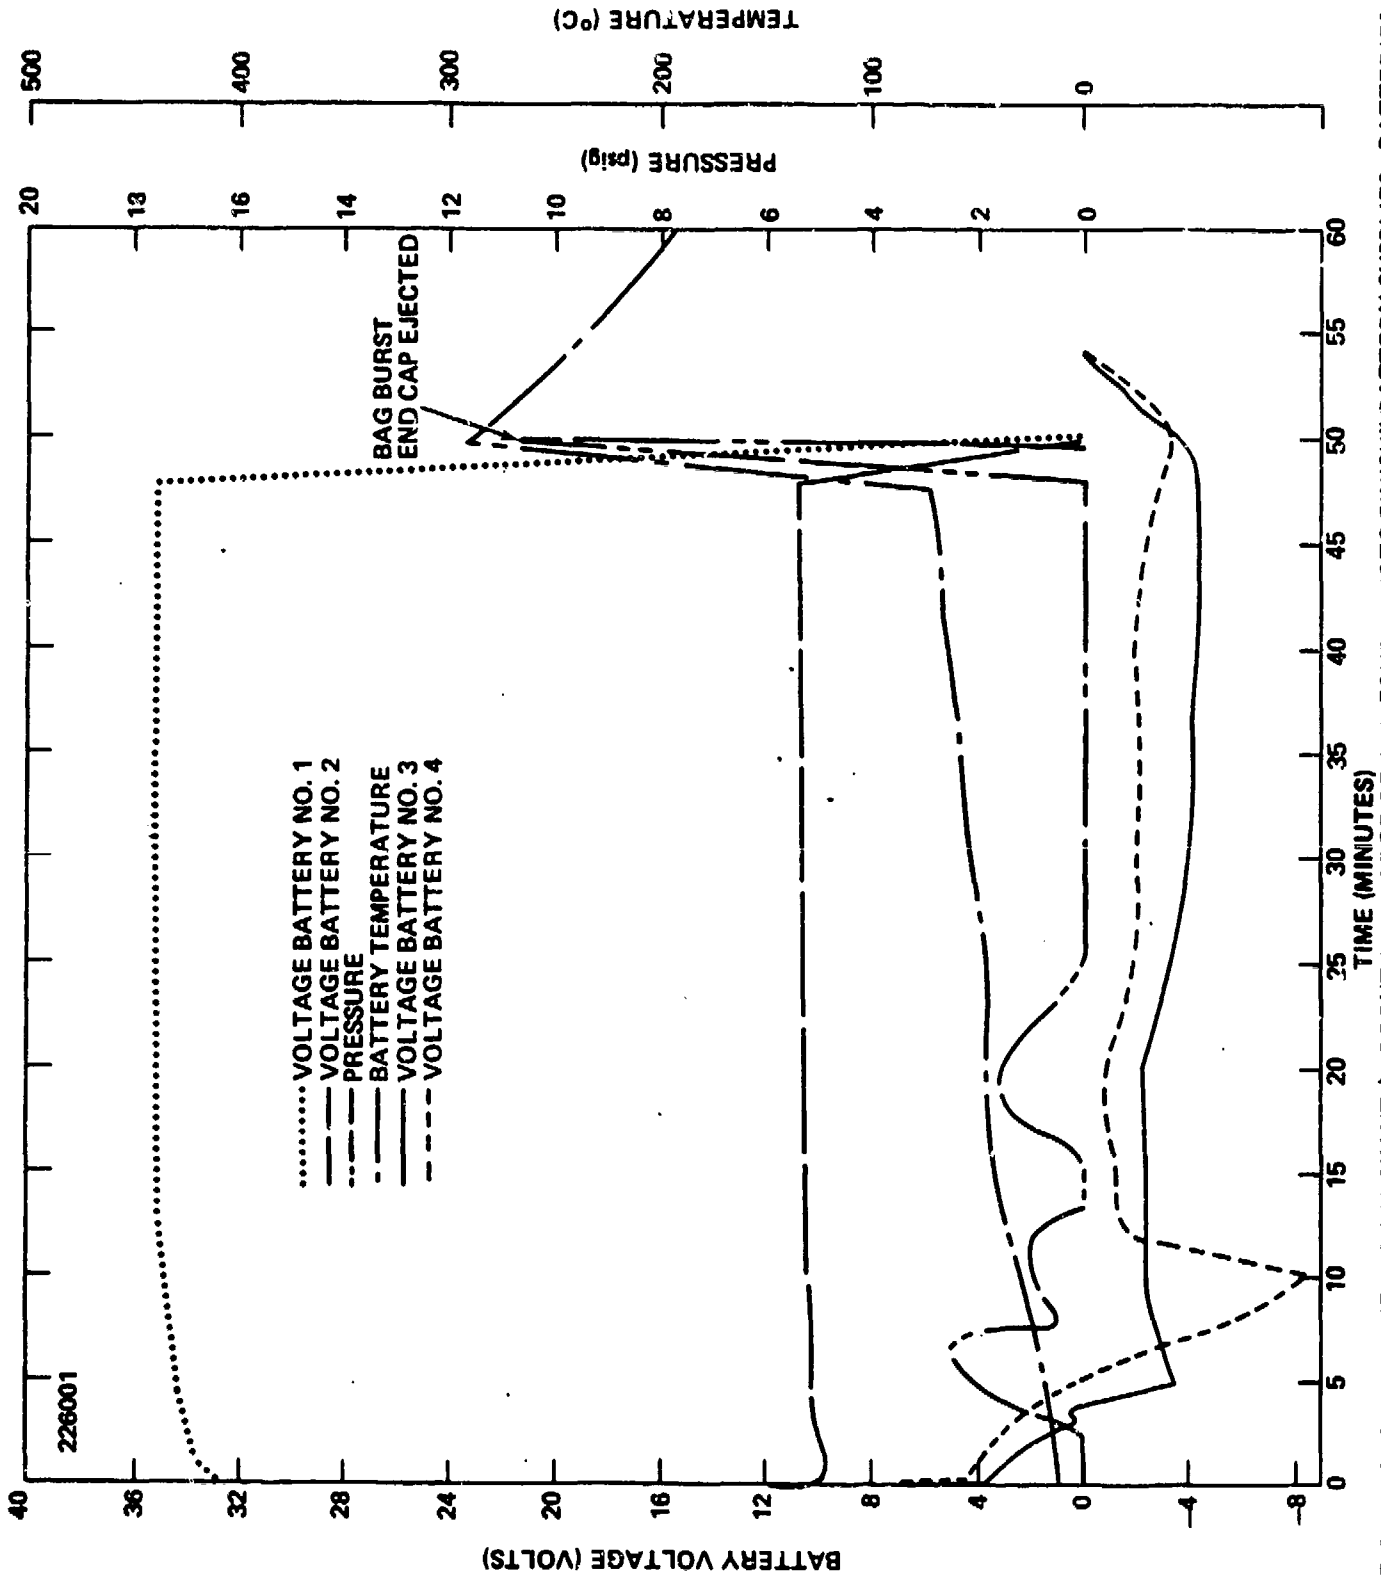
FIGURE 4 SIMULTANEOUS CONSTANT CURRENT DISCHARGE OF ALL FOUR "PHOTO FINISH" BATTERY SUPPLIES. BATTERIES ONE AND TWO WERE DISCHARGED AT FOUR AMPERES WHILE THREE AND FOUR WERE DISCHARGED AT THREE AMPERES CONSTANT CURRENT. HOUSING PRESSURE AND BATTERY PACK TEMPERATURE ARE ALSO SHOWN.

The second series of tests was simultaneous discharge of the four batteries at the fuse value using four D.C. power supplies. As in short circuit, all fuses were bypassed. Batteries one and two had thirteen and four L026SH cells in series respectively. Batteries three and four each had two L032S cells in series. Batteries one and two were discharged at four amperes while three and four were discharged at three amperes. All discharges took place at room temperature except for discharge 033001 where the buoy was preconditioned at 71°C. The results are presented in Figures 4-7. A summary of the capacities observed along with the maximum temperature observed are presented in Table 2. All four tests resulted in nose cap ejection and float bag rupture. Batteries three and four were the first to vent. In all cases the venting of batteries three and four caused the housing pressure to increase to five psig. Nose cap ejection only occurred when batteries one and two vented. A summary of the pressure and nose cap ejection velocities is presented in Table 3.

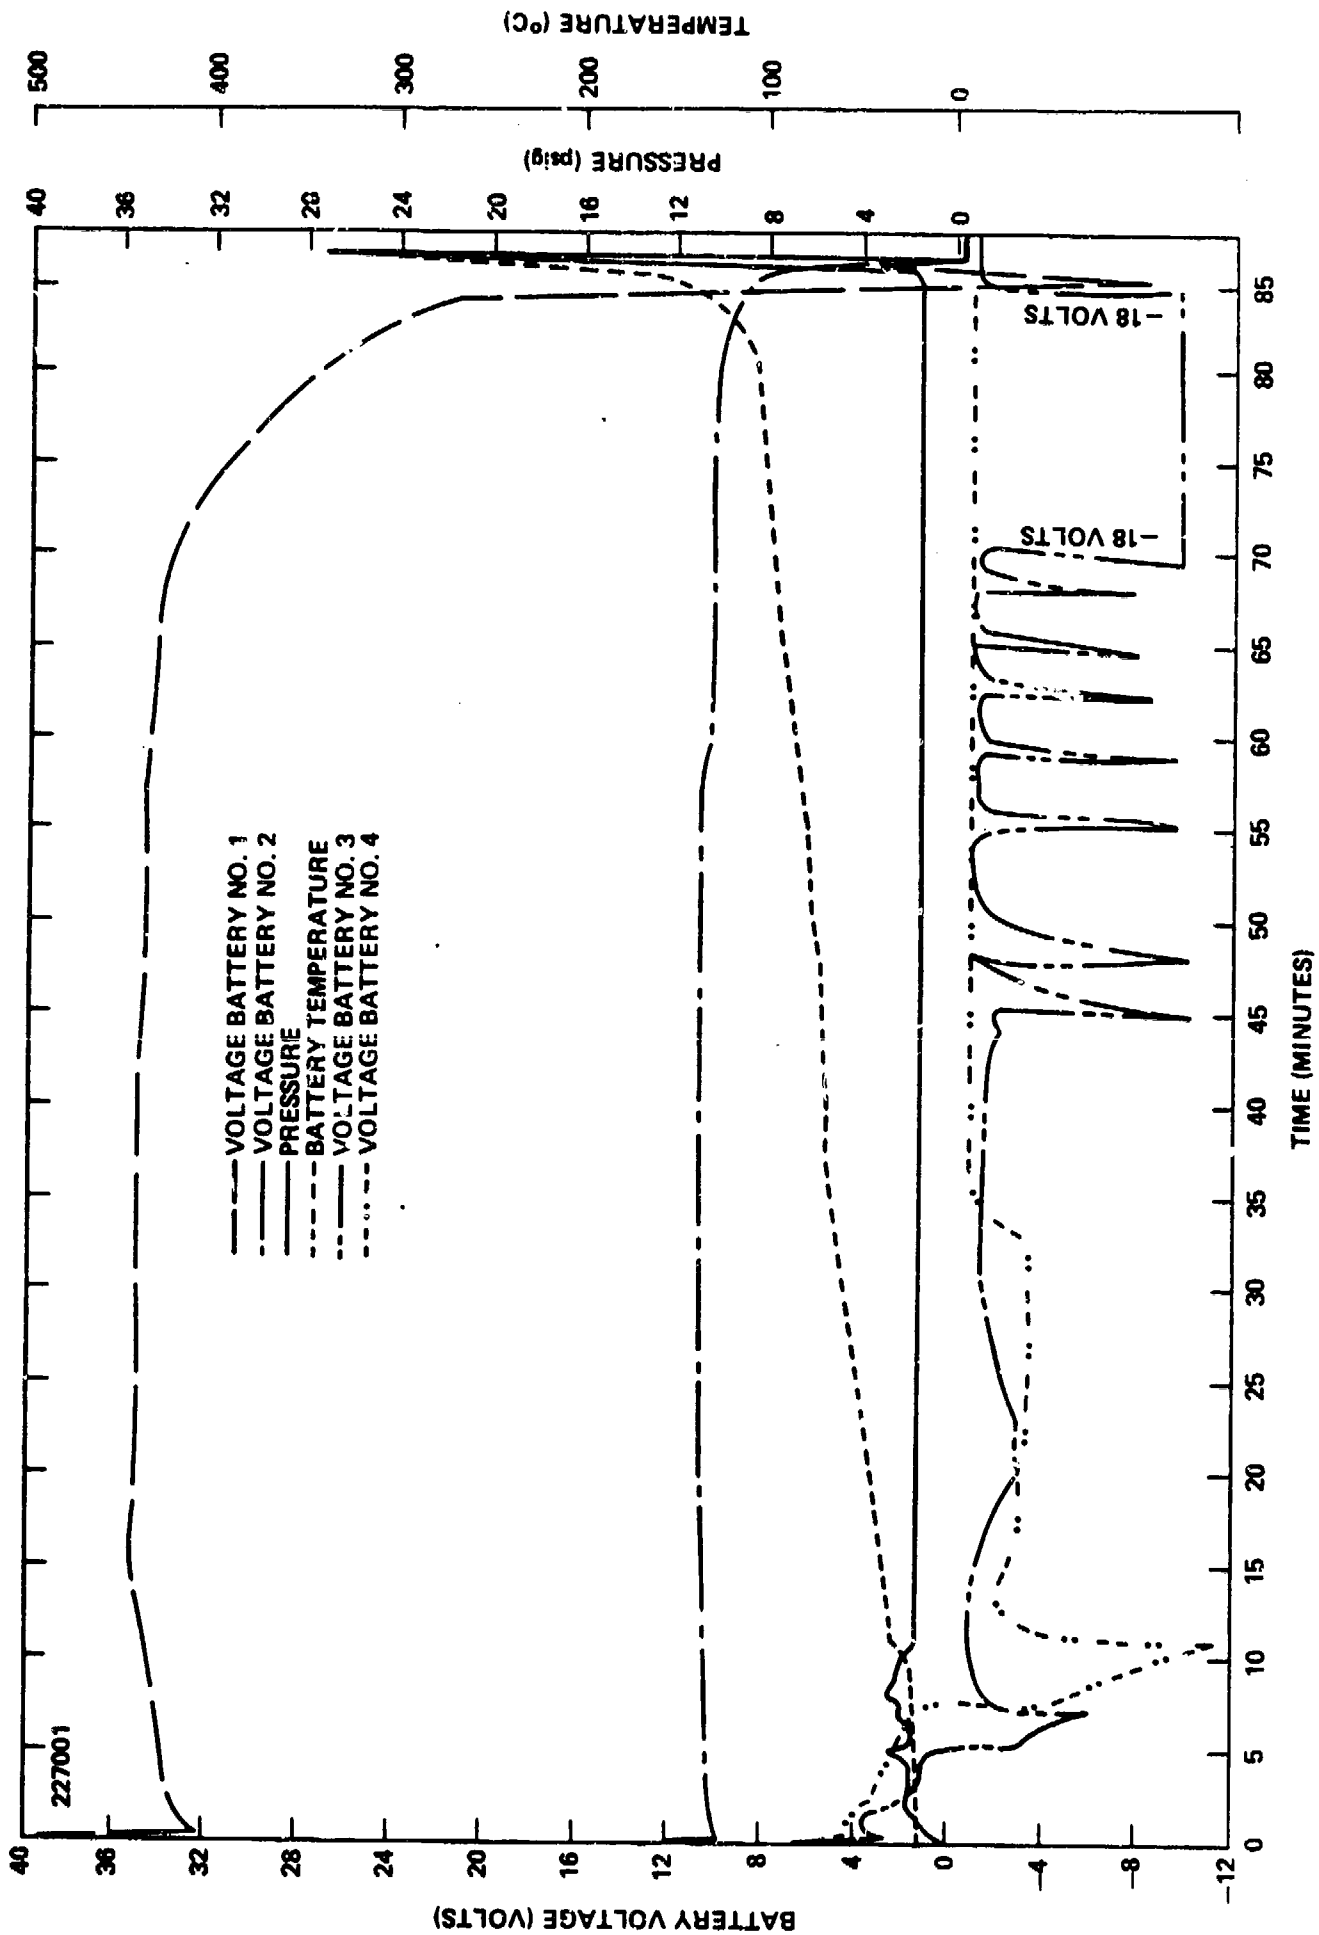
FIGURE 5 SIMULTANEOUS CONSTANT CURRENT DISCHARGE OF ALL FOUR "PHOTO FINISH" BATTERY SUPPLIES. BATTERIES ONE AND TWO WERE DISCHARGED AT FOUR AMPERES WHILE THREE AND FOUR WERE DISCHARGED AT THREE AMPERES CONSTANT CURRENT. HOUSING PRESSURE AND BATTERY PACK TEMPERATURE ARE ALSO SHOWN.

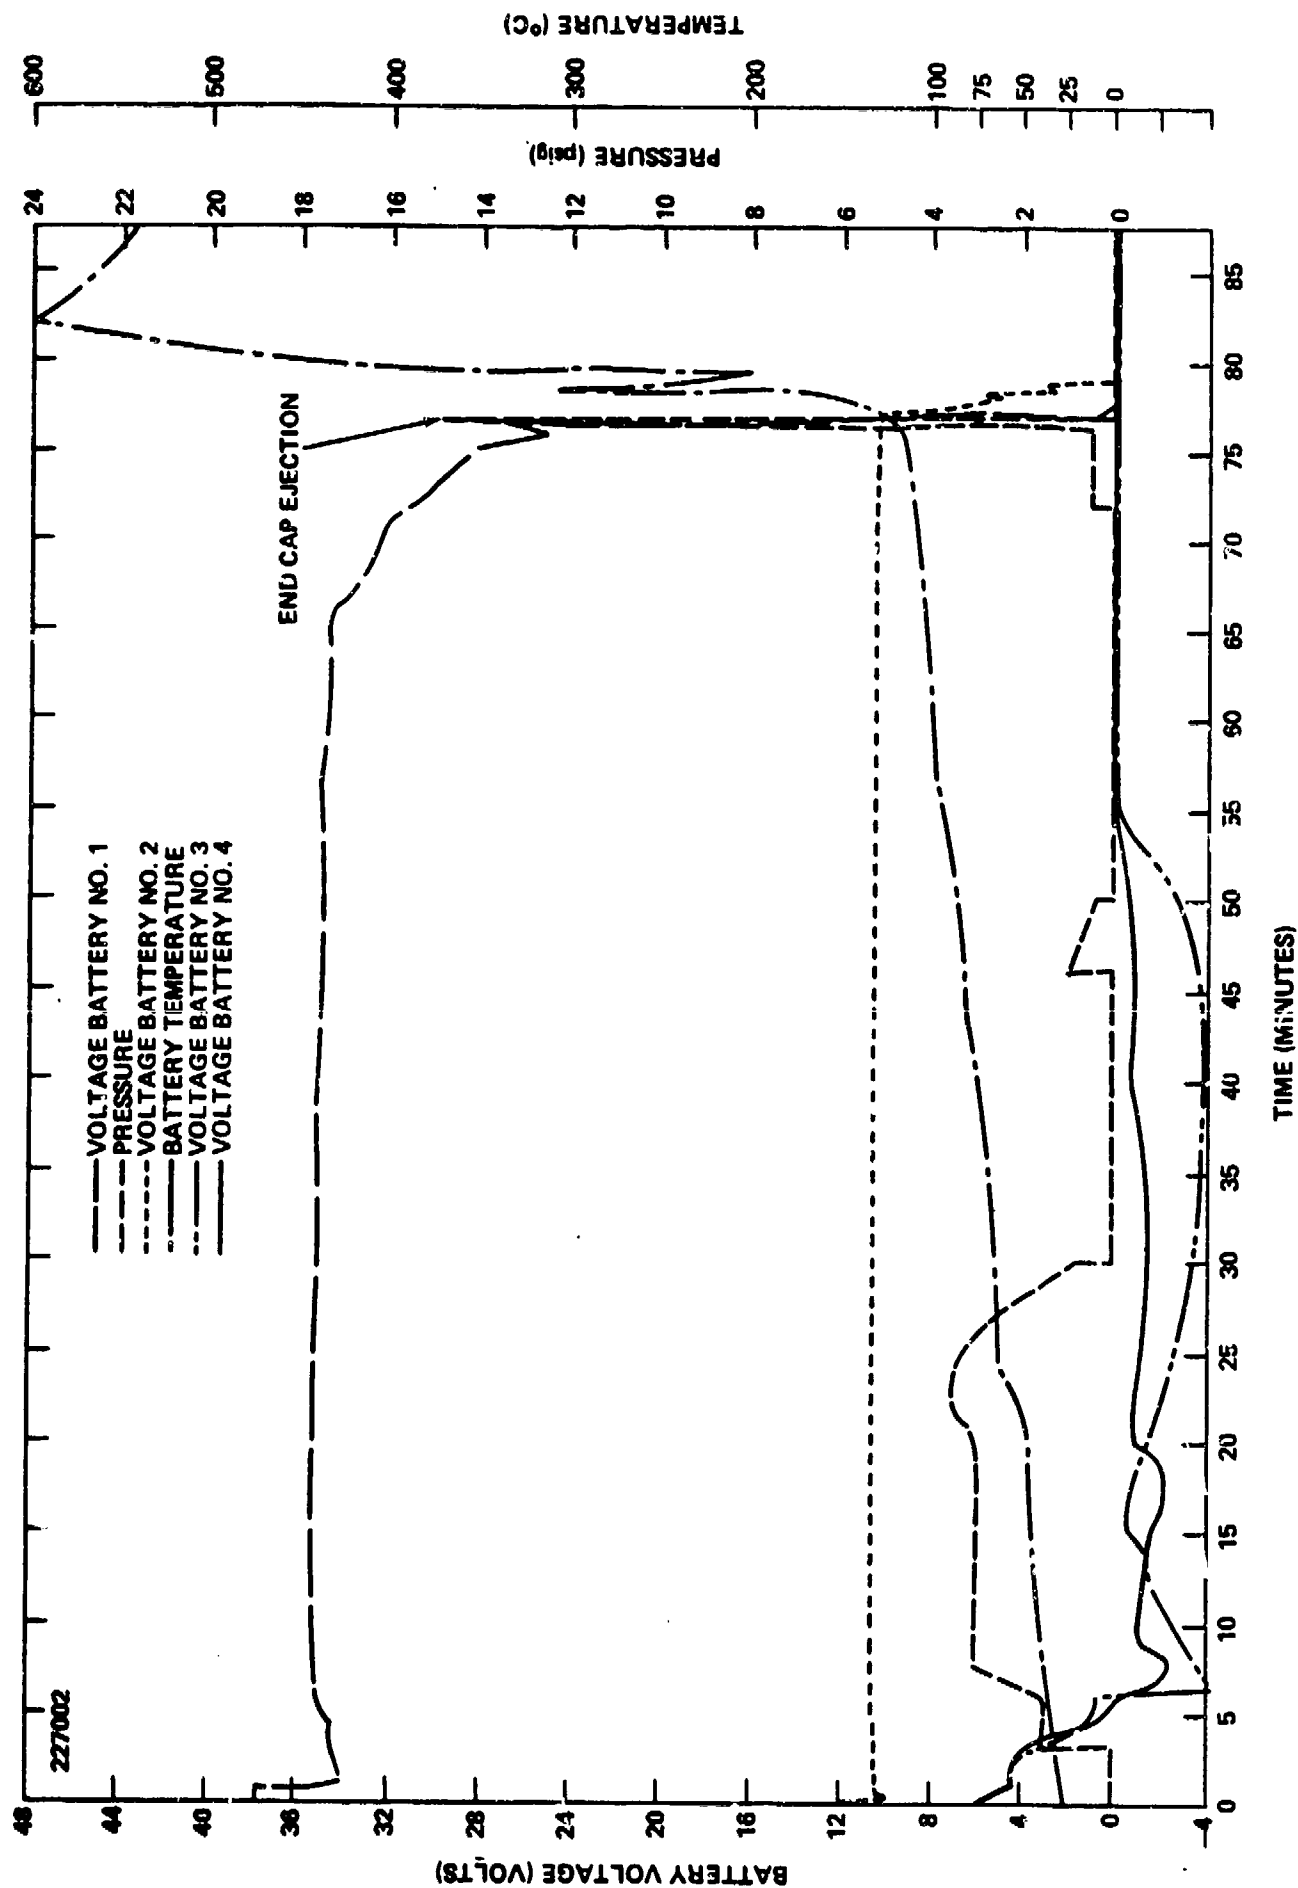
FIGURE 6 SIMULTANEOUS CONSTANT CURRENT DISCHARGE OF ALL FOUR "PHOTO FINISH" BATTERY SUPPLIES. BATTERIES ONE AND TWO WERE DISCHARGED AT FOUR AMPERES WHILE THREE AND FOUR WERE DISCHARGED AT THREE AMPERES CONSTANT CURRENT. HOUSING PRESSURE AND BATTERY PACK TEMPERATURE ARE ALSO SHOWN.

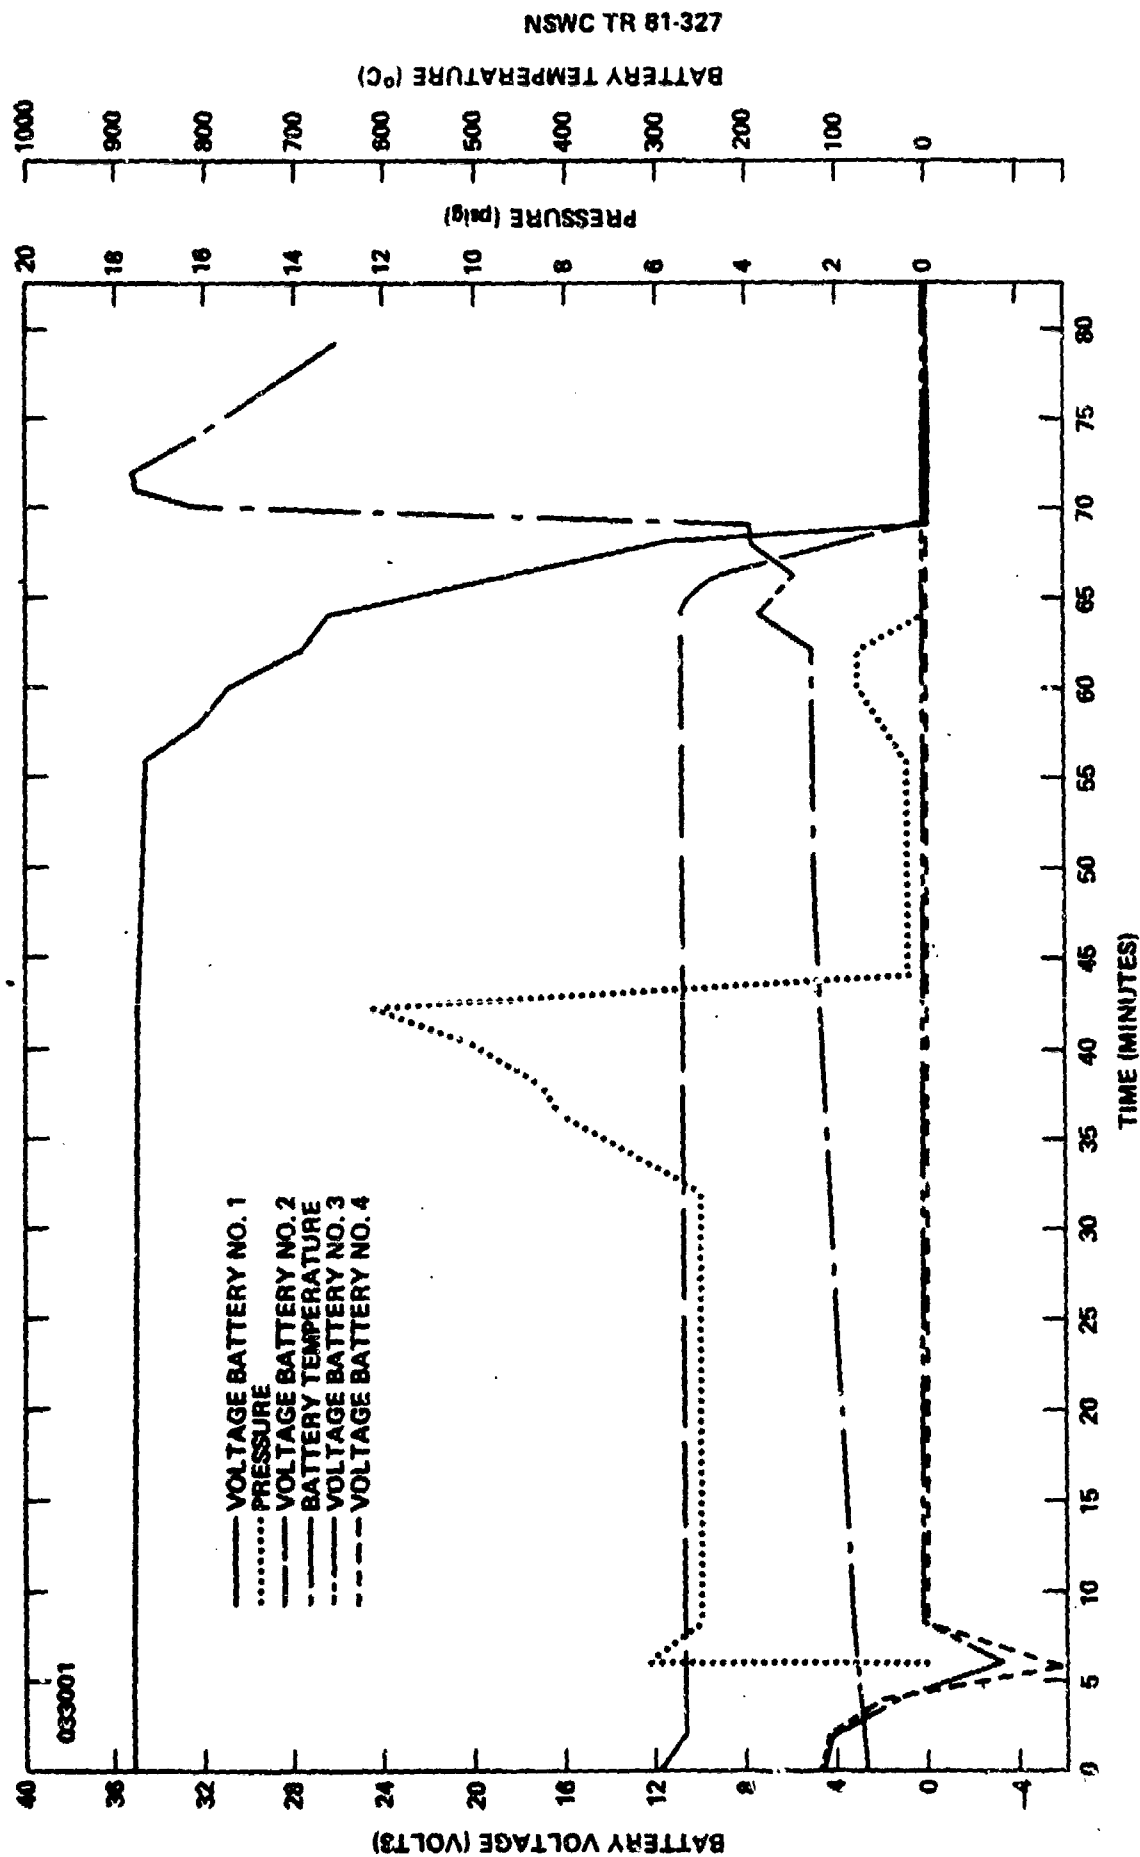
FIGURE 7 SIMULTANEOUS CONSTANT CURRENT DISCHARGE OF ALL FOUR "PHOTO FINISH" BATTERY SUPPLIES. BATTERIES ONE AND TWO WERE DISCHARGED AT FOUR AMPERES WHILE THREE AND FOUR WERE DISCHARGED AT THREE AMPERES CONSTANT CURRENT. HOUSING PRESSURE AND BATTERY PACK TEMPERATURE ARE ALSO SHOWN. THE ENTIRE "PHOTO FINISH" UNIT WAS PRECONDITIONED AT 71°C PRIOR TO DISCHARGE.

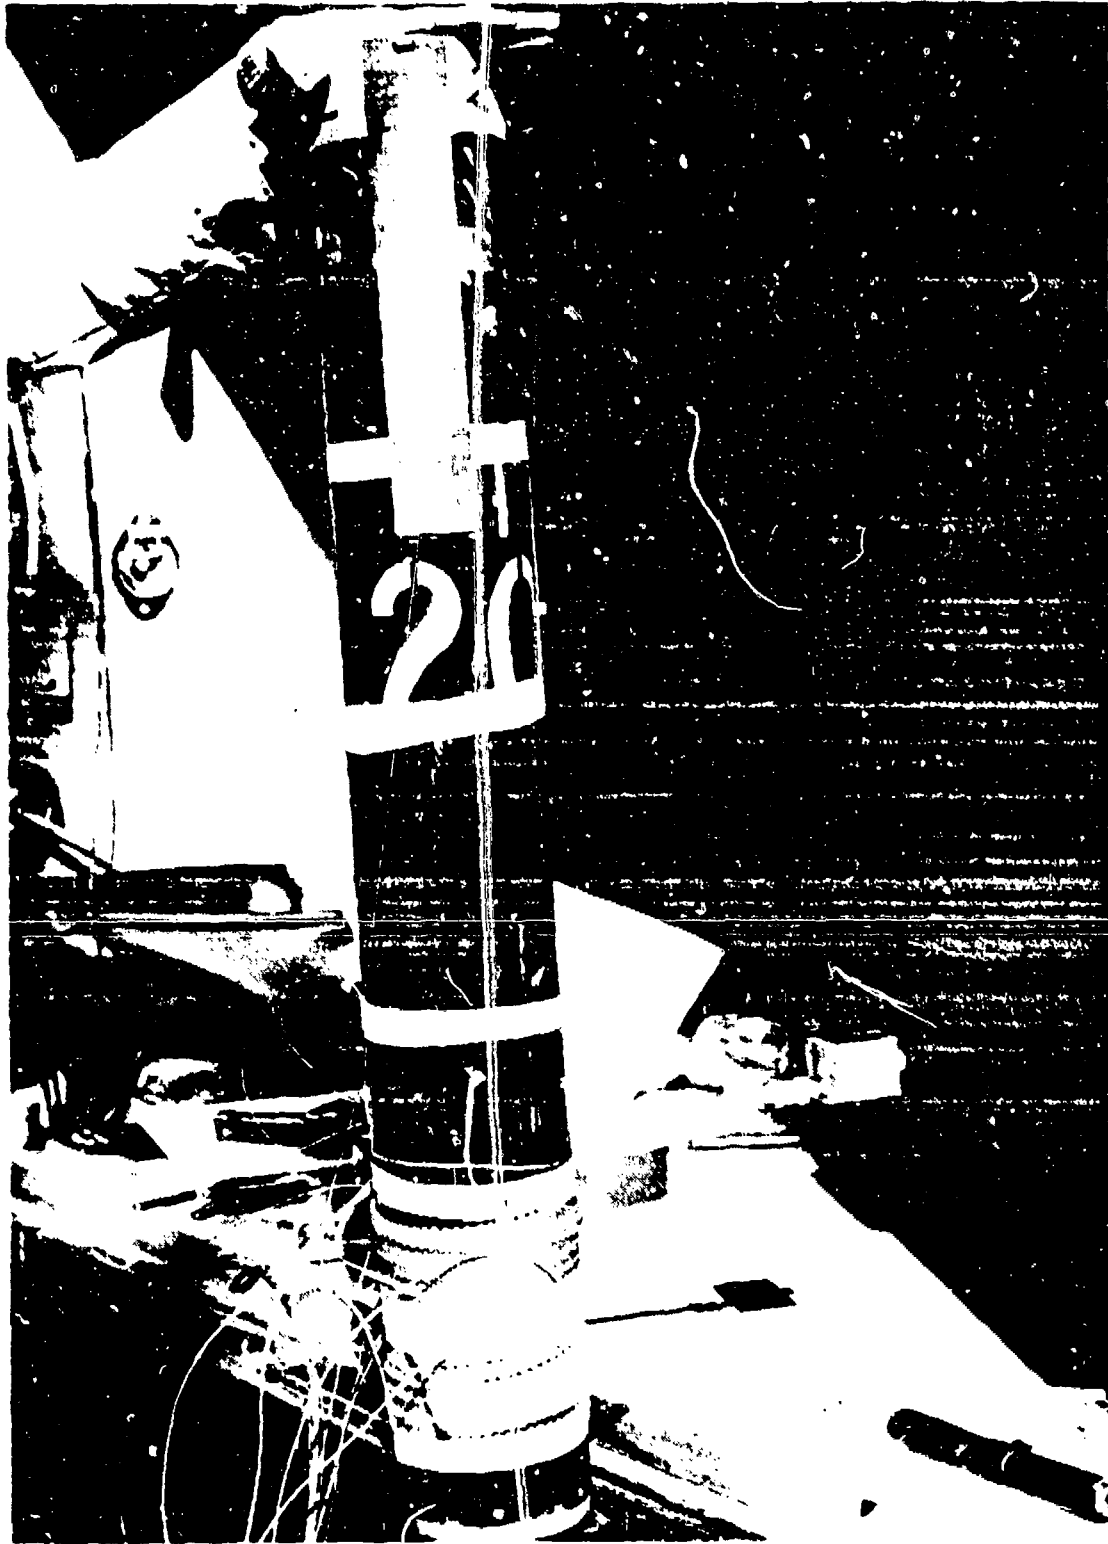
FIGURE 8 PHOTOGRAPH OF "PHOTO FINISH" UNIT WITH HEAT TAPE IN VICINITY OF BATTERY PACK

The last series of tests conducted was external heating of the battery pack by wrapping heat tape around the "PHOTO FINISH" unit in the vicinity of the battery pack. A photograph of "PHOTO FINISH" with the heat tape in place is shown in Figure 8. As in the previous tests, all fuses were bypassed. This test was repeated. The results of the heating test are presented in Figures 9 and 10. External heating forced the batteries to vent and caused a nose cap ejection similar to short circuit and constant current discharge.

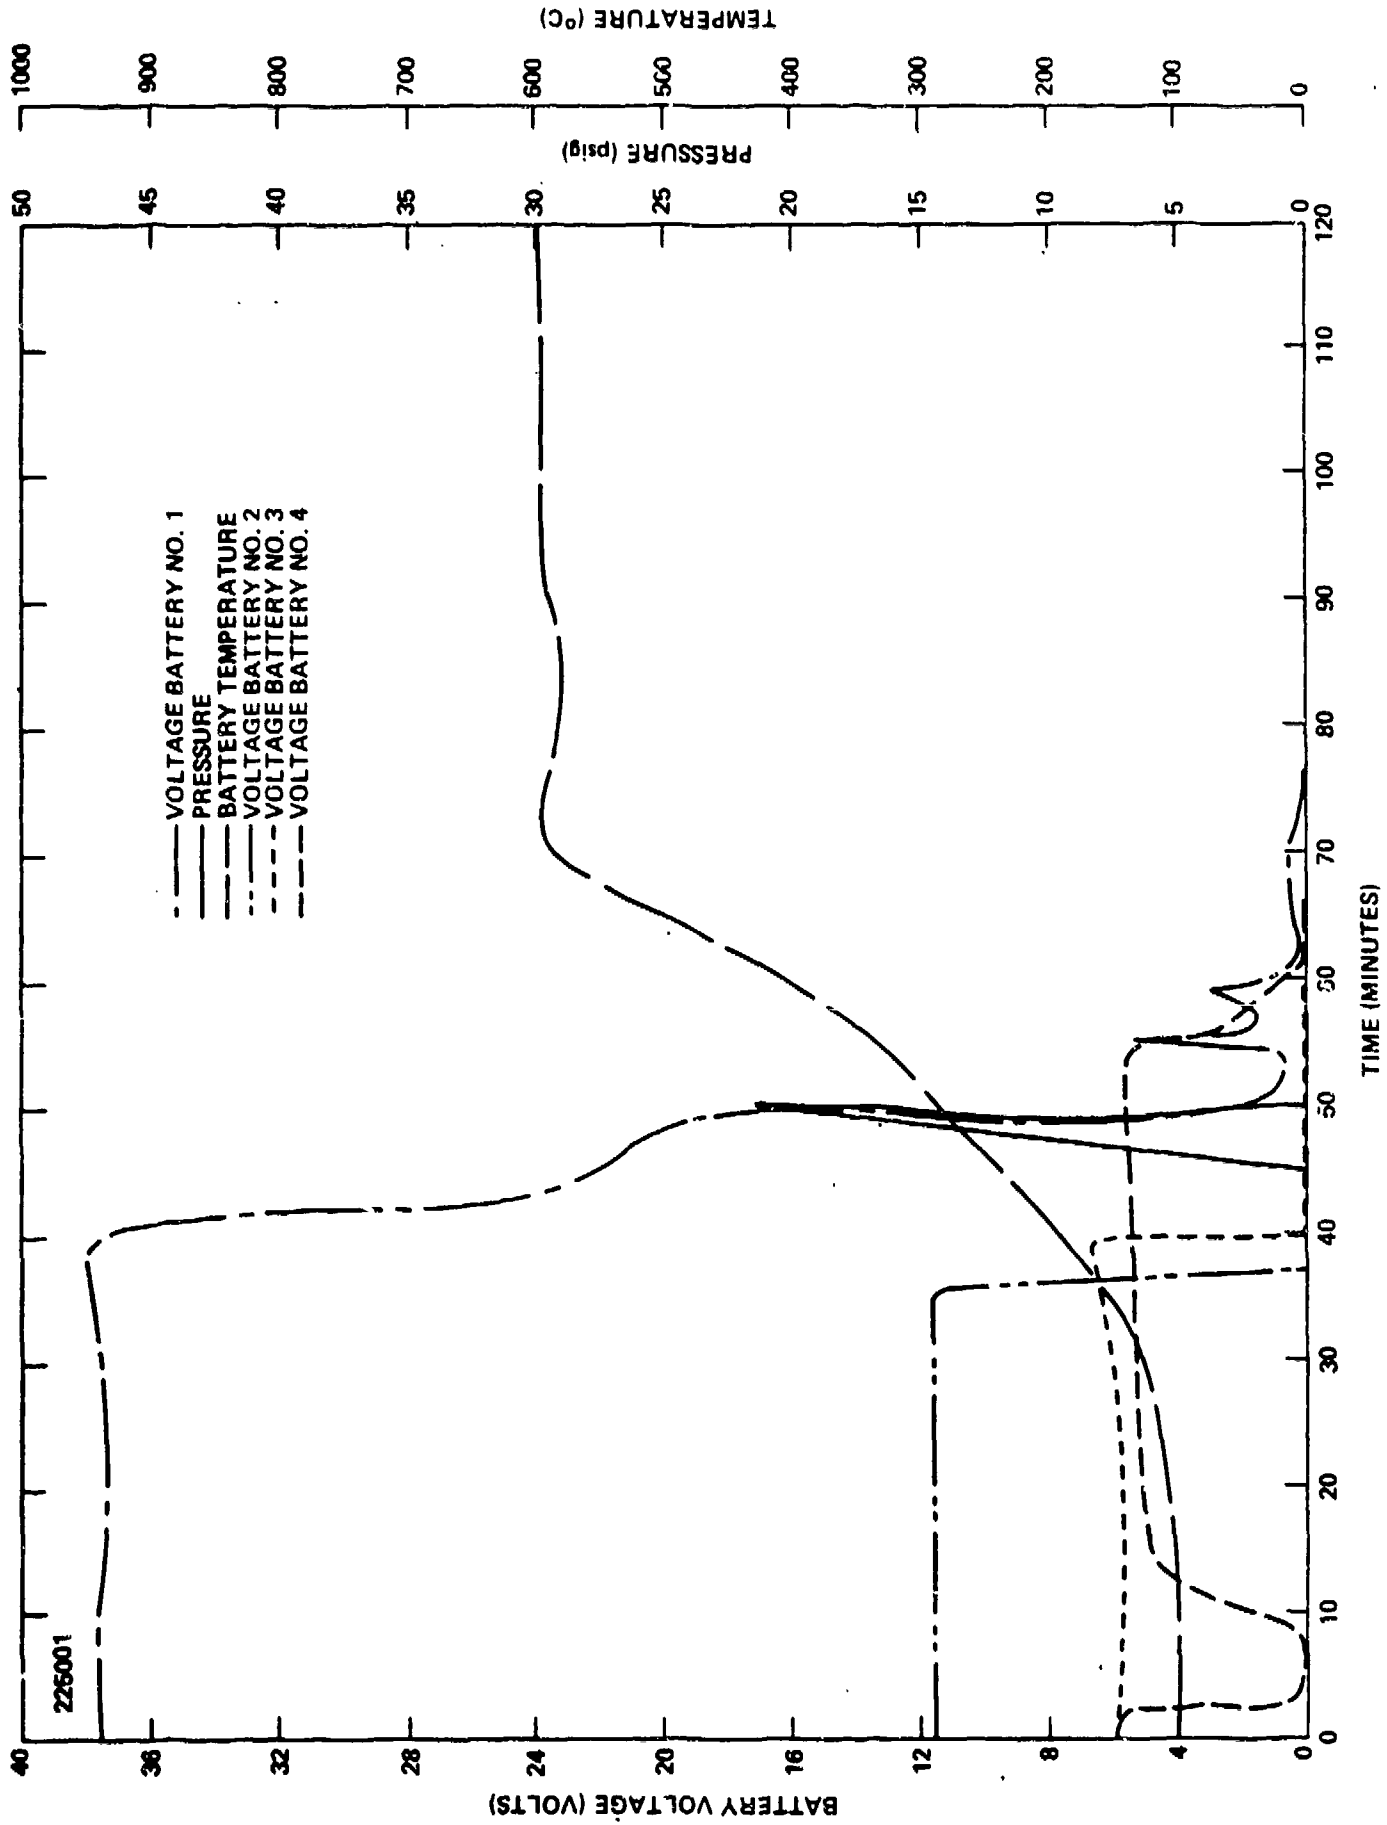
FIGURE 9 RESULTS OF EXTERNAL HEATING OF "PHOTO FINISH". THE BATTERY WAS HEATED AT APPROXIMATELY 10°C/MINUTE. BATTERY TEMPERATURE, VOLTAGES OF EACH BATTERY AND HOUSING PRESSURE ARE PLOTTED.

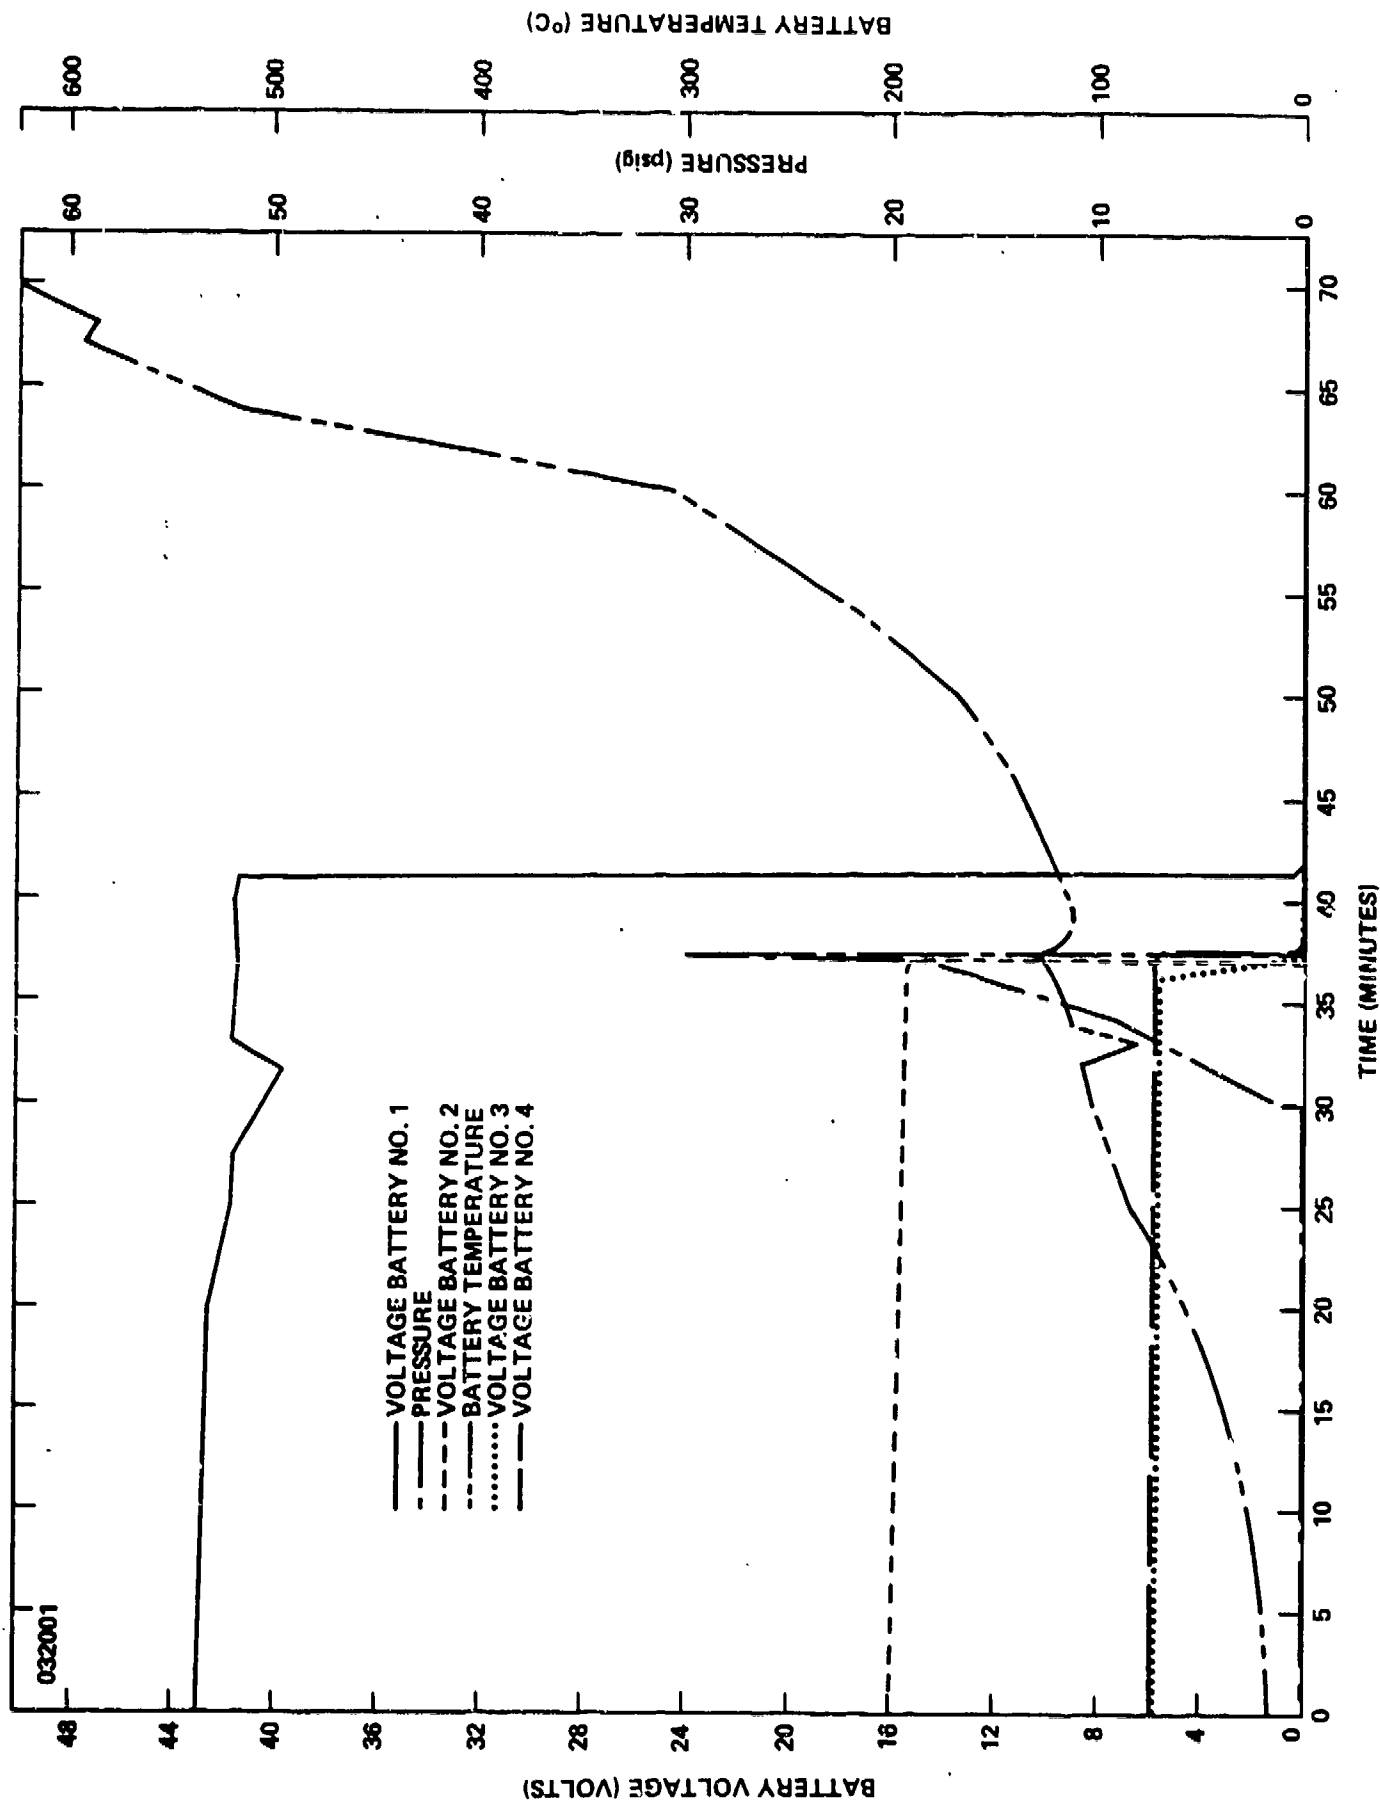
FIGURE 10 RESULTS OF EXTERNAL HEATING OF "PHOTO FINISH". THE BATTERY WAS HEATED AT APPROXIMATELY 10°C/MINUTE. BATTERY TEMPERATURE, VOLTAGES OF EACH BATTERY AND HOUSING PRESSURE ARE PLOTTED.
